**Gulf County
Cape San Blas / White Sands Project
Post-Storm Evaluation**

Prepared for:

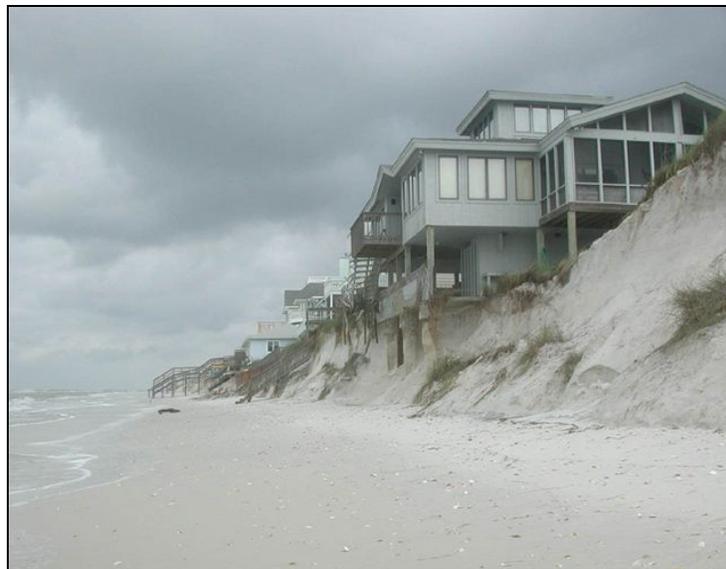
Figure 1. Pre-project condition of beachface along the five (5) properties on White Sands Drive. Note the homes (289 White Sands Drive in forefront) are beginning to be undermined by the scalloping of the dunes, Jay Sample, ACT Inc.

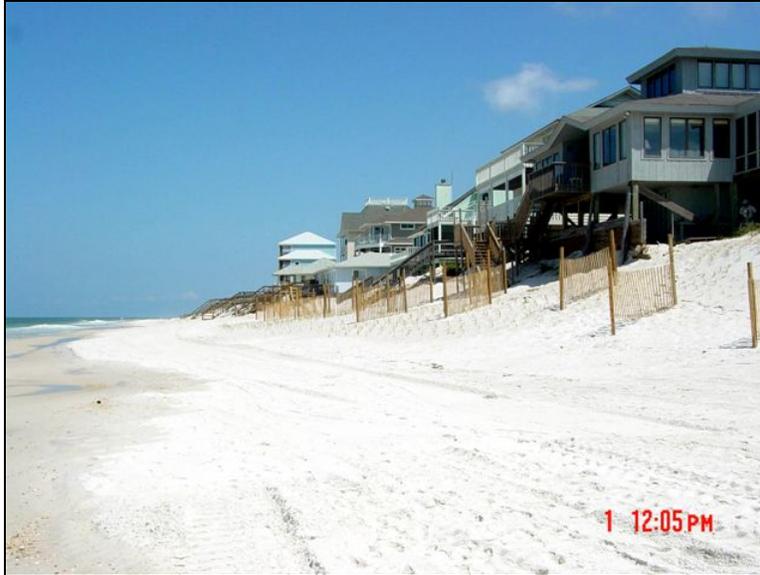
Figure 3. ProTecTube site showing dune rebuilding and re-vegetation upon completion of installation and prior to storm events. 289 White Sands Drive is first house on right. Jay Sample, ACT Inc.

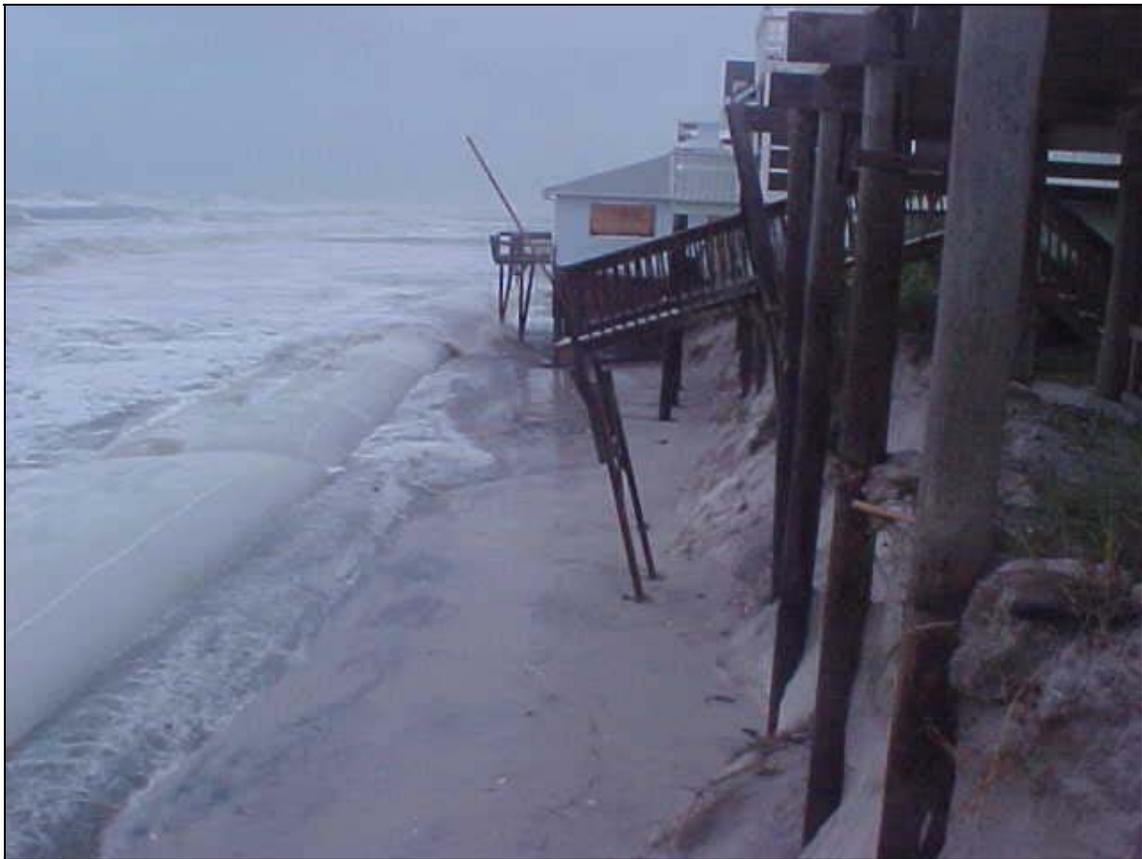
Figure 4. View of waves during Hurricane Ivan overtopping geotube system and trapped water running between geotubes and project site homes. Jay Sample, ACT Inc. (September, 2004)

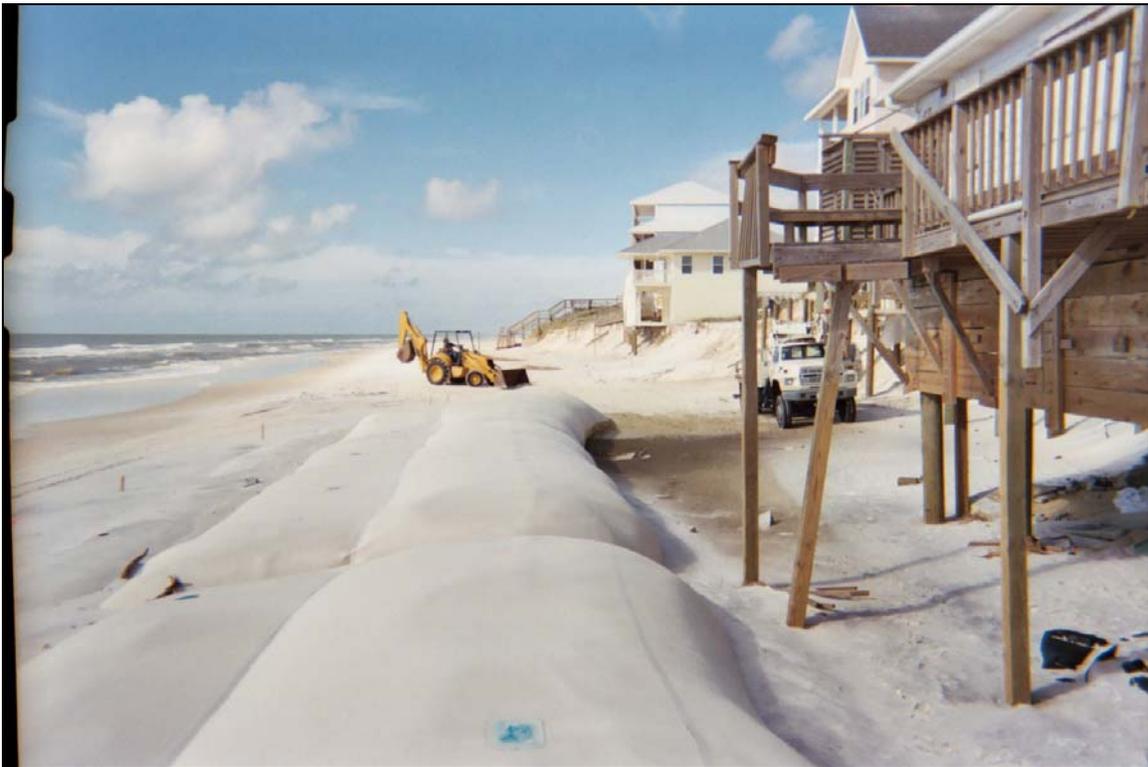
Figure 5. Post-storm damage showing scouring of dunes beneath structures as a direct result of wave action evidenced by Figure 4. Jeffrey R. Tabar, PBS&J (November, 2004)

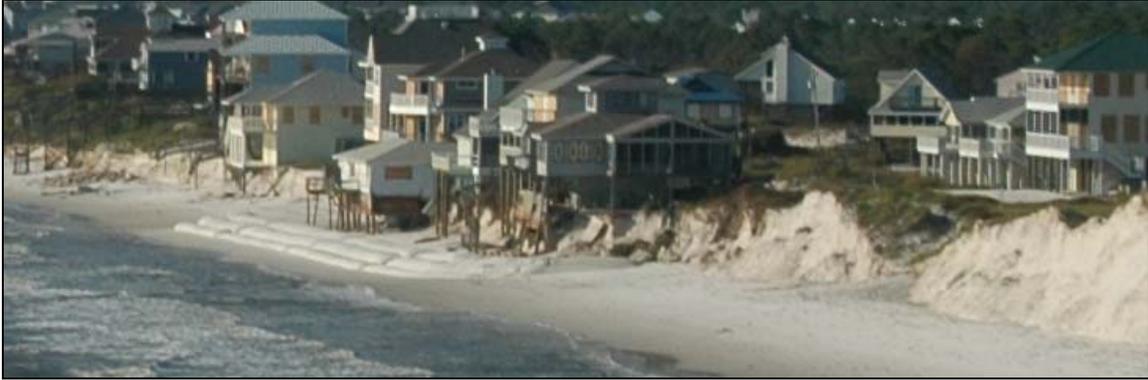
Figure 6. Aerial photograph looking northward showing similar erosional trends on both project, and non-project beaches. The dunes directly behind the geotubes show a state of erosion that is more advanced than pre-project conditions and exhibits an erosional rate similar to adjacent beaches. Florida Dept. of Environmental Protection (September 17, 2004)

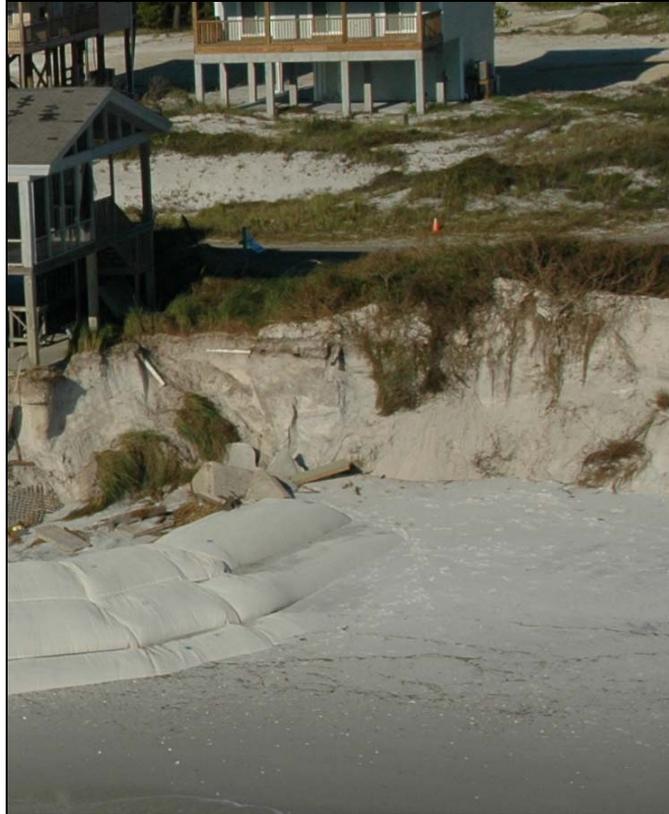
Figure 7. Aerial photograph showing increased dune scalloping around southern terminus of geotubes caused when the geotube return was flanked (289 White Sands Drive visible on the left. *Florida Department of Environmental Protection (September 17, 2004)*

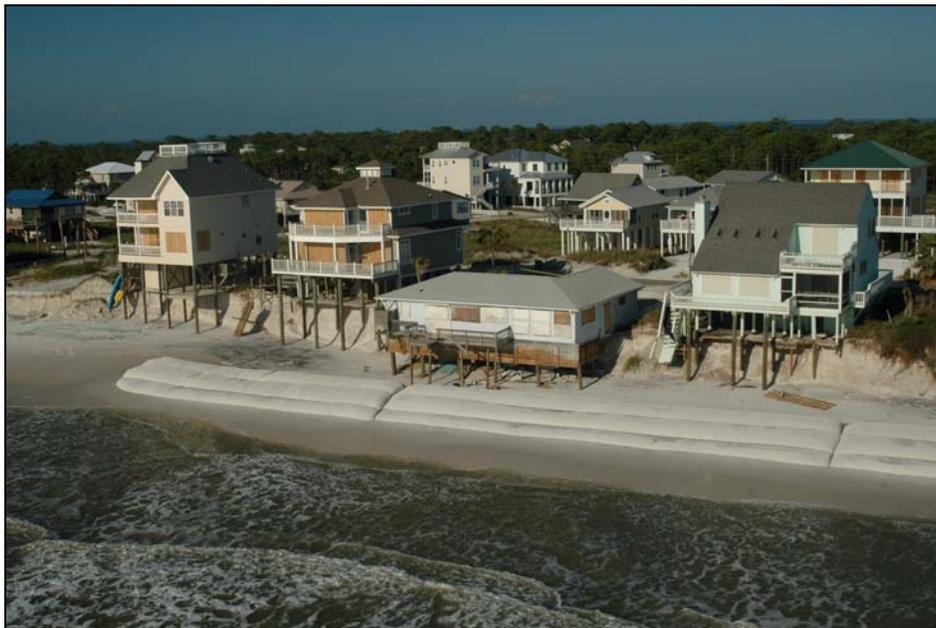
Figure 8. Aerial photograph showing increased dune scalloping around northern terminus of geotubes caused when the geotube return was flanked. *Florida Department of Environmental Protection (September 17, 2004)*
